HOUSATONIC RIVER BASIN  
WASHINGTON, MASSACHUSETTS

SANDWASH DAM  
MA 00316

PHASE I INSPECTION REPORT  
NATIONAL DAM INSPECTION PROGRAM

AUGUST 1981

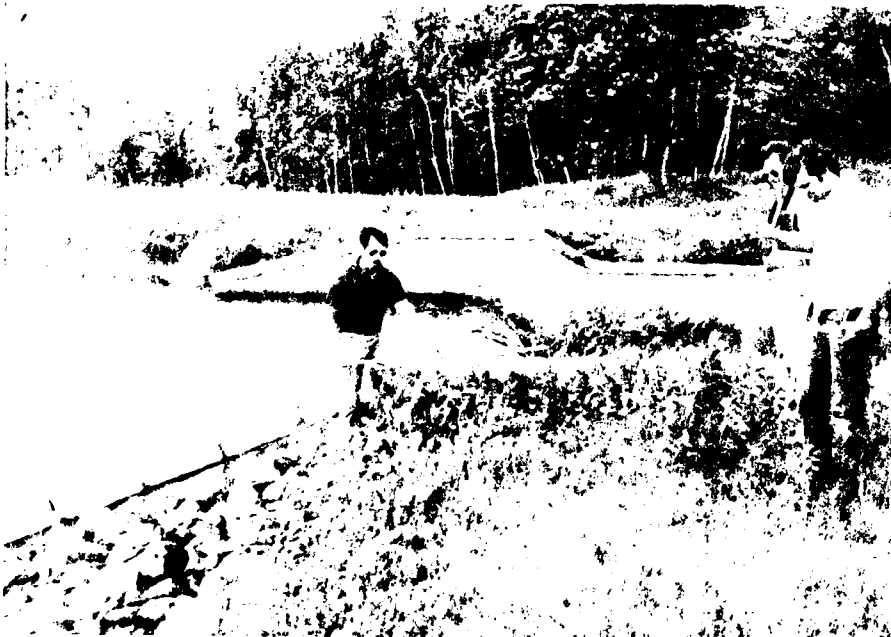
The dam crest is grass covered and well maintained with no sign of movement or cracking. The crest of the right and left sections of the dam are shown in photograph 15 and 10 respectively. The only area of subsidence is that shown below the ruler in photograph 12 discussed above.

PHOTO NO. 12 - Area of subsidence of crest behind right wall of spillway below ruler in photo.

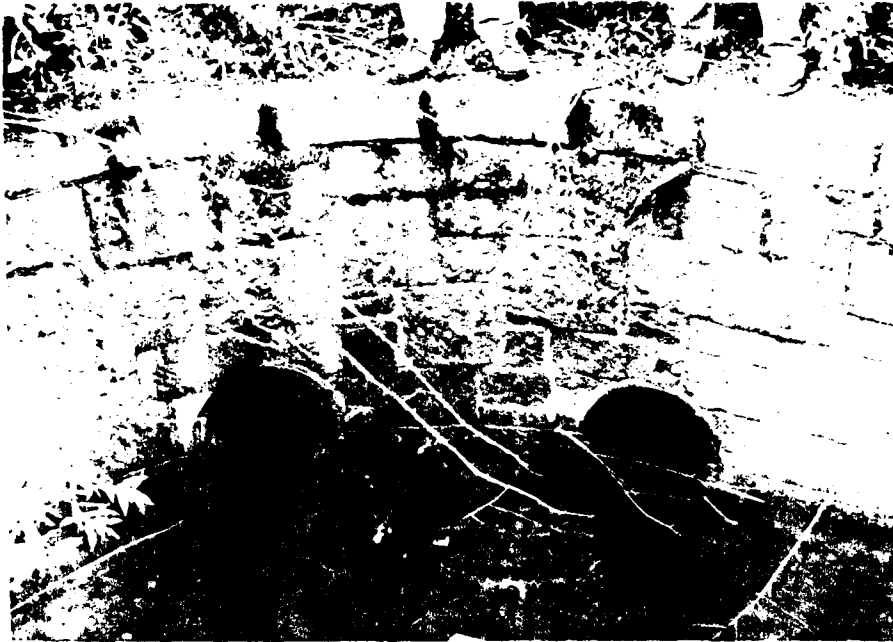
PHOTO NO.9 - View of 18 inch and 16 inch outlet pipes and headwall structure located about 200 feet below toe of dam.

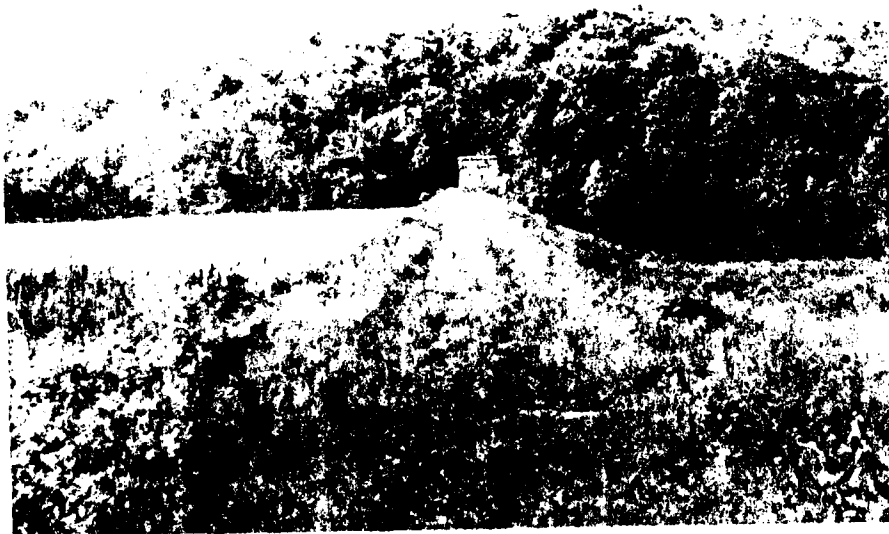
PHOTO NO.10 - Crest of left half of dam.

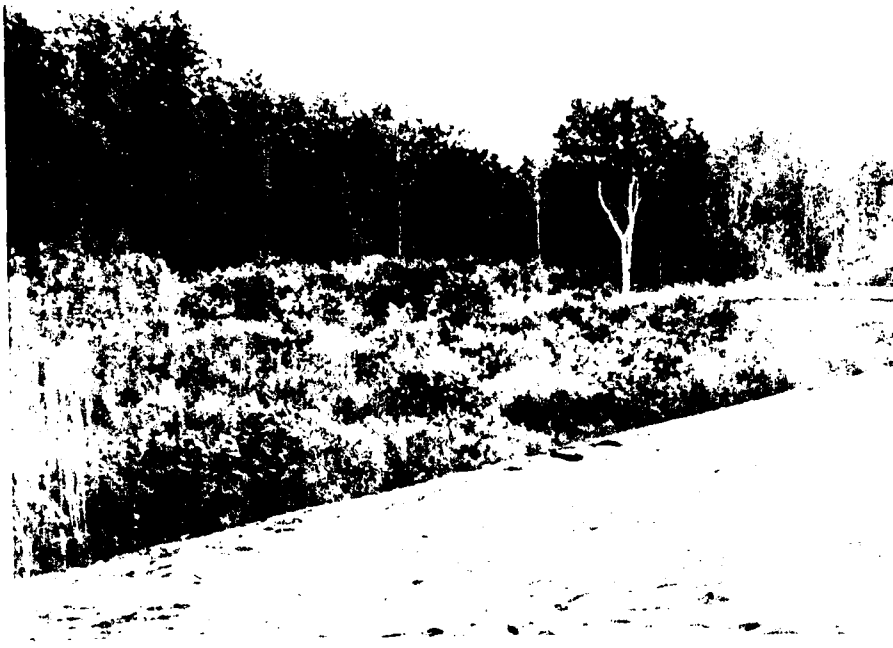
PHOTO NO.5 - General view of spillway discharge channel.

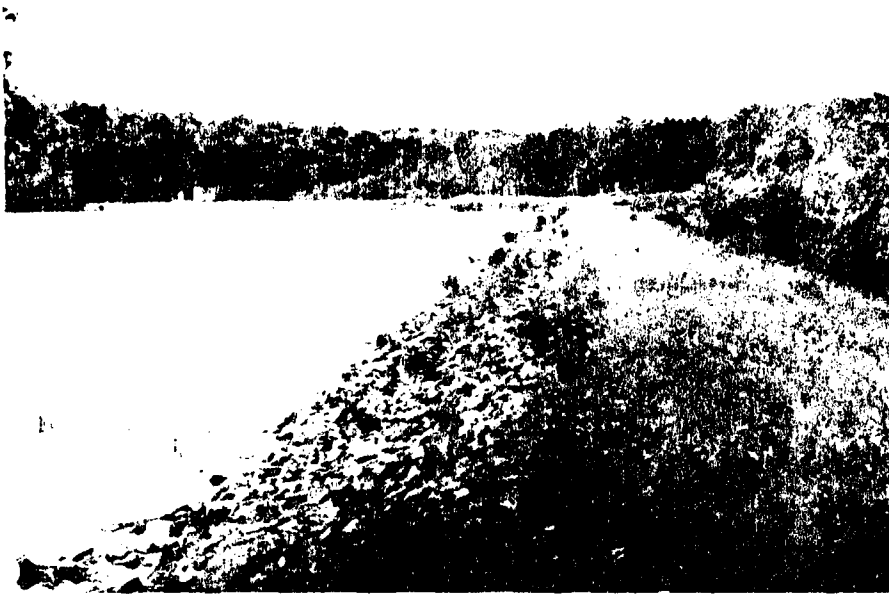
The upstream face of the dam is sloped at 2 1/2H:1V above elevation 1881 and 3-1/4H:1V below elevation 1881 based on the design drawings and field measurements above the water level. The visible riprap was generally in good condition on both the left and right sections of the dam, as shown in photographs 1 and 3, respectively. Some small brush is growing on these slopes.

PHOTO NO.3 - View of upstream face of right half of dam embankment. View of gate-house structure in left background portion of photo.

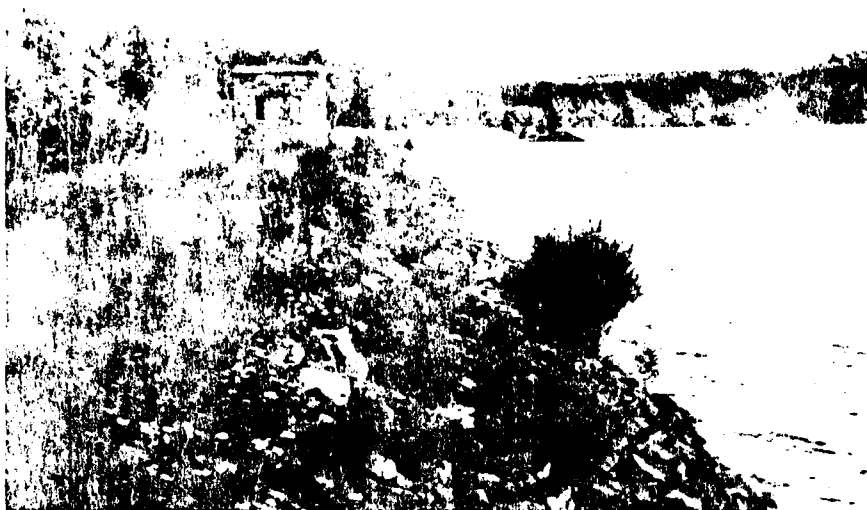
PHOTO NO.1 - View of gatehouse structure and upstream side slope of left half of dam embankment.

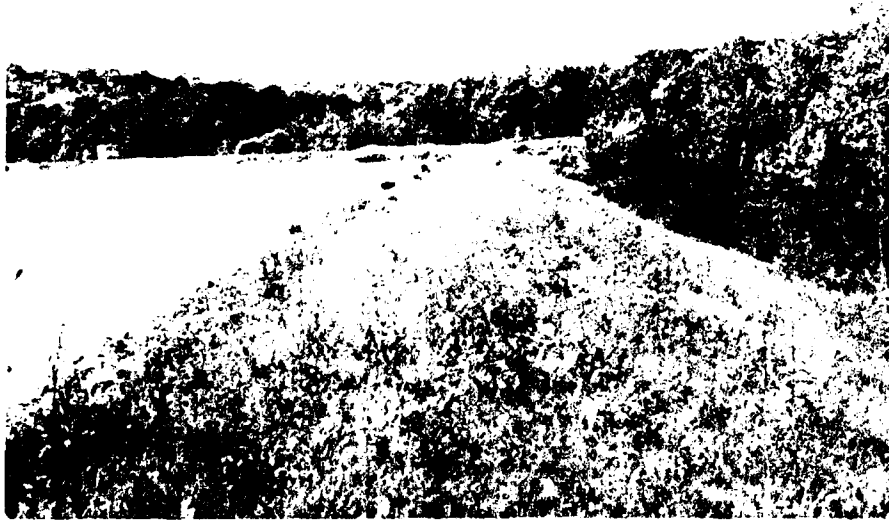
PHOTO NO.15 - General view of crest of right half of dam.

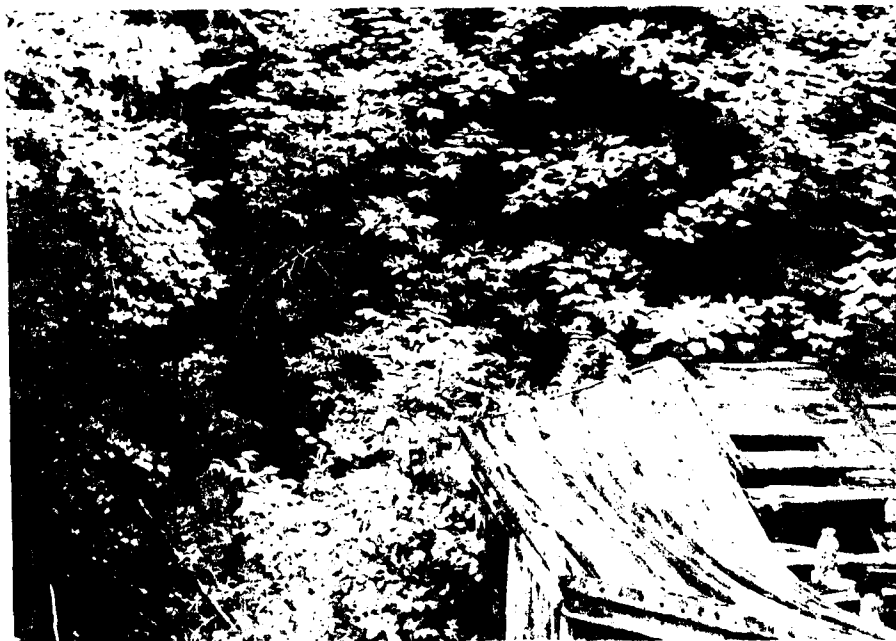
The downstream outlet structure masonry headwall was observed to be in good condition. The gates at the control chamber have not been operated in many years. They are kept in a position which diverts water directly to the outlet headwall. The aerator structure is basically abandoned and has not been in use in many years. See photographs 16 and 17.

PHOTO NO. 17 - View of Aerator Structure.
